Flood Control Project Maintenance
2011 Structure Summary Report
Overall Unit and Item Ratings

Lake County Watershed Protection District

Flood Control Project Maintenance**Unit Cover Sheet****2011 Structure Inspection Results****Lake County Watershed Protection District**

Levee Inspection Report By Mile - Structure 2011

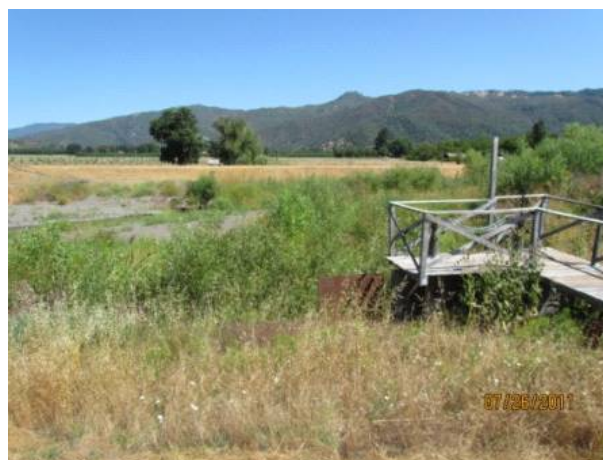
Levee Mile Report Line	1
Start Levee Mile	0.00
End Levee Mile	0.00
Location	
Category	Structures
Item	Photo Documentation

LMR No.	Levee Mile		Category	Item	Location	Rating	Action/Comment	GPS Latitude/Longitude		Issue No.
	Start	End						Start	End	Photo
1	0.00	0.00	Structures	Photo Documentation			Inspector Comments: Clover Creek Diversion Structure has three culverts with both flap and slide gates to divert the water during high water season.	39.177050 ° -122.898750 °	39.177050 ° -122.898750 °	1 Y
2	0.00	0.00	Structures	Vegetation & Obstructions		M	Inspector Comments: The channel had vegetation and scattered obstructions.	39.177050 ° -122.898750 °	39.177050 ° -122.898750 °	2 Y
3	0.00	0.00	Structures	Shoaling / Sedimentation		M	Inspector Comments: Minimal amount of shoaling and sedimentation were present on the channel.	39.177050 ° -122.898750 °	39.177050 ° -122.898750 °	3 Y
4	0.00	0.00	Structures	Erosion / Bank Caving		A	Inspector Comments: There were no visible active erosion or bank caving observed.	39.177050 ° -122.898750 °	39.177050 ° -122.898750 °	4

View of the diversion structure.

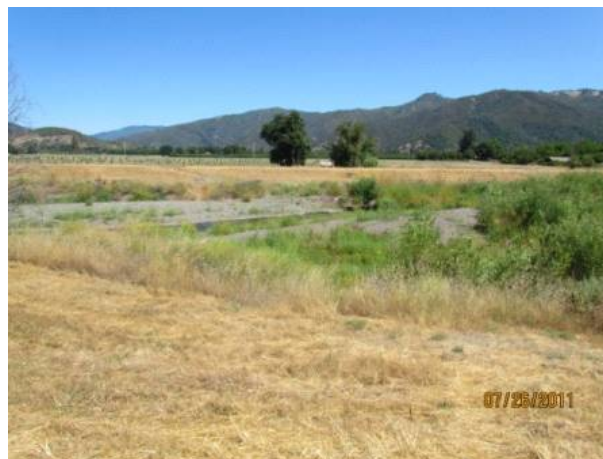
Levee Mile Report Line	2
Start Levee Mile	0.00
End Levee Mile	0.00
Location	
Category	Structures
Item	Vegetation & Obstructions

View of the channel.

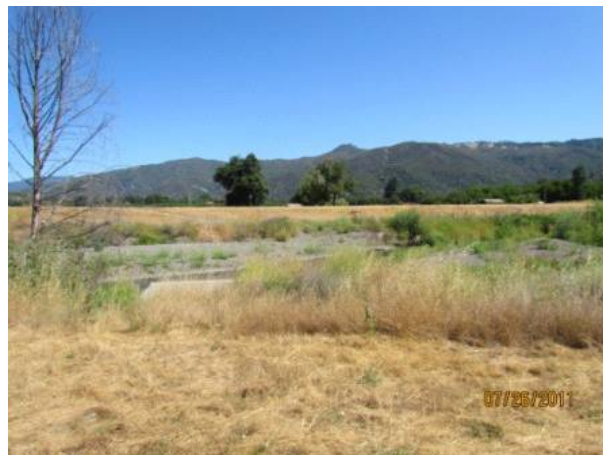
Levee Mile Report Line	3
Start Levee Mile	0.00
End Levee Mile	0.00
Location	
Category	Structures
Item	Shoaling / Sedimentation

View of the clover creek channel.

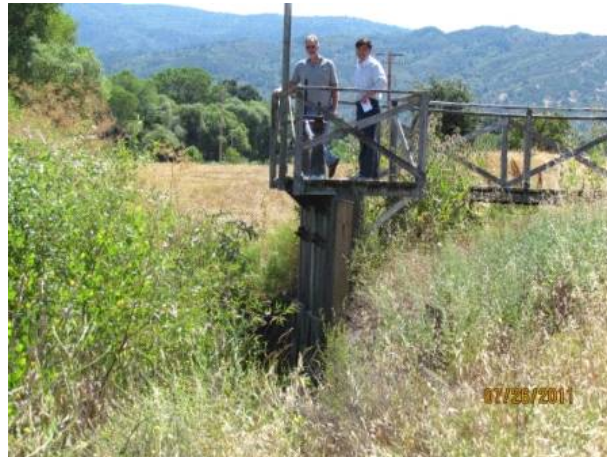
Levee Mile Report Line	7
Start Levee Mile	0.00
End Levee Mile	0.00
Location	
Category	Structures
Item	Culverts: Inlets / Outlets
View of the culvert inlet.	
pkazi_t_20110803_023.jpg

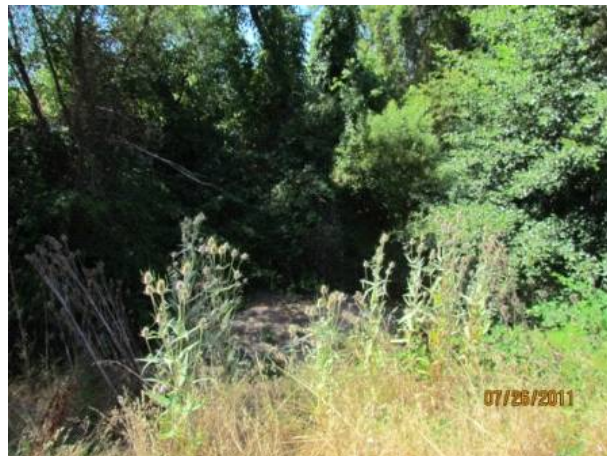
Levee Mile Report Line	7
Start Levee Mile	0.00
End Levee Mile	0.00
Location	
Category	Structures
Item	Culverts: Inlets / Outlets
View of the culvert outlet.	
pkazi_t_20110803_030.jpg

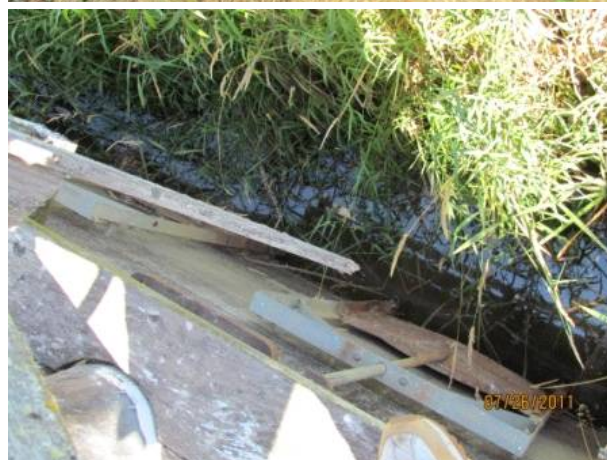
11	0.00	0.00	Structures	Flap Gates		A	Inspector Comments: Flap gates appeared to be in good condition.	39.177050 ° -122.898750 °	39.177050 ° -122.898750 °	11
12	0.00	0.00	Structures	Sluice/Slide Gates		A	Inspector Comments: The slide gates appeared to be in good working condition.	39.177050 ° -122.898750 °	39.177050 ° -122.898750 °	12 Y
13	0.00	0.00	Structures	Electric Gate Operators		N	Inspector Comments: This item does not apply to this inspection.	39.177050 ° -122.898750 °	39.177050 ° -122.898750 °	13
14	0.00	0.00	Structures	Manual Gate Operators		A	Inspector Comments: The manual gate operator appeared to be operational.	39.177050 ° -122.898750 °	39.177050 ° -122.898750 °	14 Y

Levee Mile Report Line	12
Start Levee Mile	0.00
End Levee Mile	0.00
Location	
Category	Structures
Item	Sluice/Slide Gates
View of the slide gate.	
pkazi_t_20110803_026.jpg

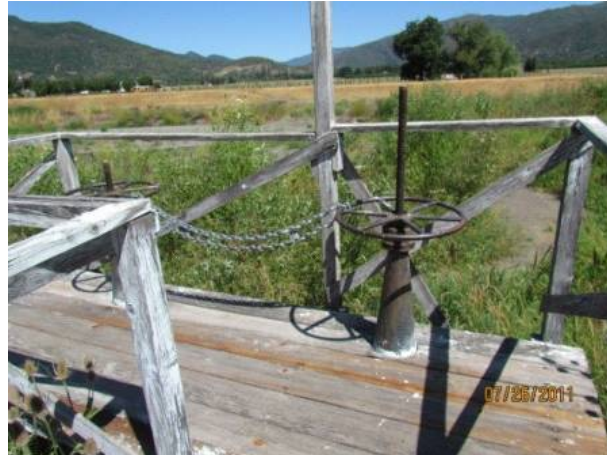
Levee Mile Report Line	14
Start Levee Mile	0.00
End Levee Mile	0.00
Location	
Category	Structures
Item	Manual Gate Operators

View of the manual gate operator.

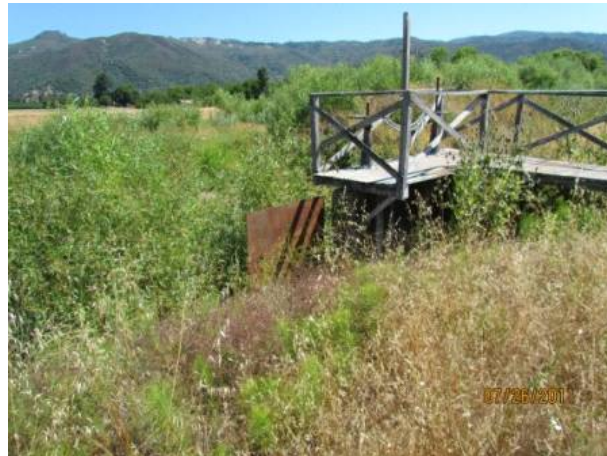
Levee Mile Report Line	23
Start Levee Mile	0.00
End Levee Mile	0.00
Location	
Category	Structures
Item	Safety

20	0.00	0.00	Structures	Trash Rakes		N	Inspector Comments: This item does not apply to this inspection.	39.177050 ° -122.898750 °	39.177050 ° -122.898750 °	20
21	0.00	0.00	Structures	Other Metallic Items		N	Inspector Comments: This item does not apply to this inspection.	39.177050 ° -122.898750 °	39.177050 ° -122.898750 °	21
22	0.00	0.00	Structures	Monolith Joints		N	Inspector Comments: This item does not apply to this inspection.	39.177050 ° -122.898750 °	39.177050 ° -122.898750 °	22
23	0.00	0.00	Structures	Safety		M	Inspector Comments: The wood railing around the structure was not sturdy but appeared to provide fall protection.	39.177050 ° -122.898750 °	39.177050 ° -122.898750 °	23 Y

View of the guard railing.

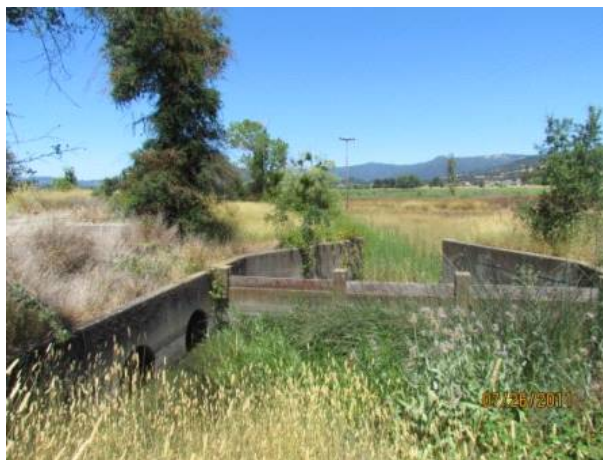
Levee Mile Report Line	1
Start Levee Mile	0.00
End Levee Mile	0.00
Location	
Category	Structures
Item	Photo Documentation

LMR No.	Levee Mile		Category	Item	Location *	Rating **	Action/Comment	GPS Latitude/Longitude		Issue No.
	Start	End						Start	End	Photo
1	0.00	0.00	Structures	Photo Documentation			Inspector Comments: Highland Canal Diversion Weir works as a control point that diverts water through a culvert during high water season.	39.126317 ° -122.882733 °	39.126317 ° -122.882733 °	1 Y
2	0.00	0.00	Structures	Vegetation & Obstructions		M	Inspector Comments: There were vegetation growth such as cat tails and bushes in the structure which might impede the flow of the water through the culvert.	39.126317 ° -122.882733 °	39.126317 ° -122.882733 °	2 Y
3	0.00	0.00	Structures	Shoaling / Sedimentation		A	Inspector Comments: No Shoaling or sedimentation was present.	39.126317 ° -122.882733 °	39.126317 ° -122.882733 °	3
4	0.00	0.00	Structures	Erosion / Bank Caving		A	Inspector Comments: No active erosion or active bank caving was observed around the structure.	39.126317 ° -122.882733 °	39.126317 ° -122.882733 °	4

View of the weir.

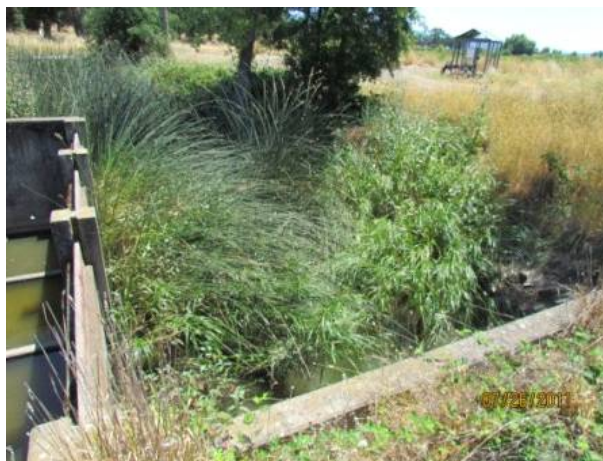
Levee Mile Report Line	2
Start Levee Mile	0.00
End Levee Mile	0.00
Location	
Category	Structures
Item	Vegetation & Obstructions

View of the vegetation growth on the structure.

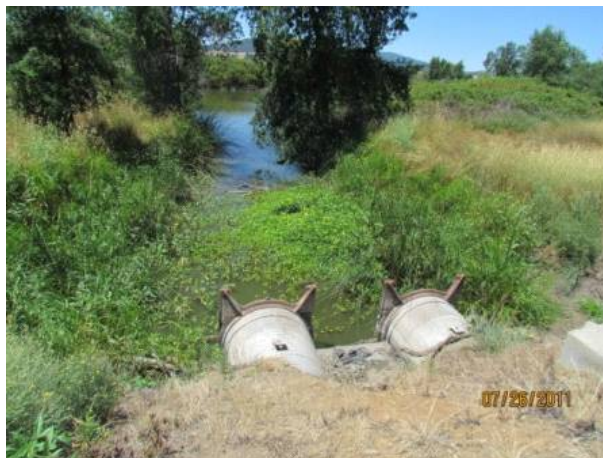
Levee Mile Report Line	2
Start Levee Mile	0.00
End Levee Mile	0.00
Location	
Category	Structures
Item	Vegetation & Obstructions

View of vegetation on the outlet of the structure.

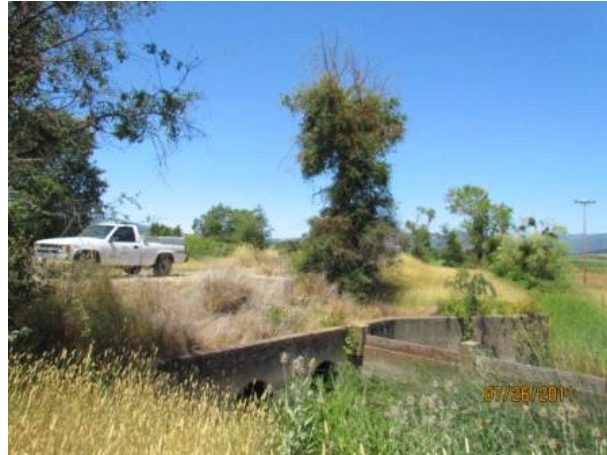
Levee Mile Report Line	7
Start Levee Mile	0.00
End Levee Mile	0.00
Location	
Category	Structures
Item	Culverts: Inlets / Outlets

View of the culvert opening.

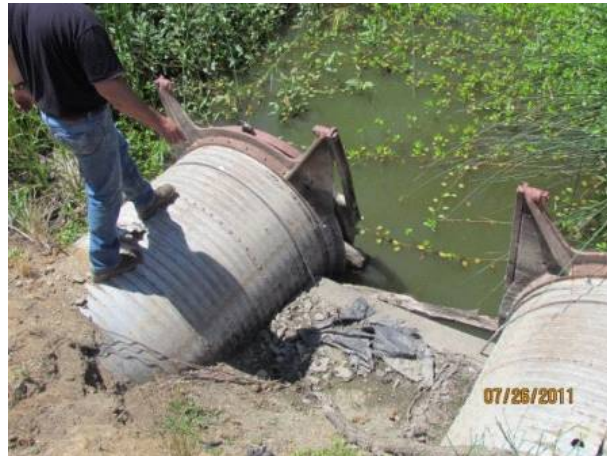
Levee Mile Report Line	11
Start Levee Mile	0.00
End Levee Mile	0.00
Location	
Category	Structures
Item	Flap Gates

11	0.00	0.00	Structures	Flap Gates		M	Inspector Comments: There was a log stuck in the flap gate which resulted the gate to be partially open.	39.126317 ° -122.882733 °	39.126317 ° -122.882733 °	11 Y
12	0.00	0.00	Structures	Sluice/Slide Gates		N	Inspector Comments: This item does not apply to this inspection.	39.126317 ° -122.882733 °	39.126317 ° -122.882733 °	12
13	0.00	0.00	Structures	Electric Gate Operators		N	Inspector Comments: This item does not apply to this inspection.	39.126317 ° -122.882733 °	39.126317 ° -122.882733 °	13
14	0.00	0.00	Structures	Manual Gate Operators		A	Inspector Comments: Manual gate operator appeared to be in good working condition.	39.126317 ° -122.882733 °	39.126317 ° -122.882733 °	14

View of the flap gate.

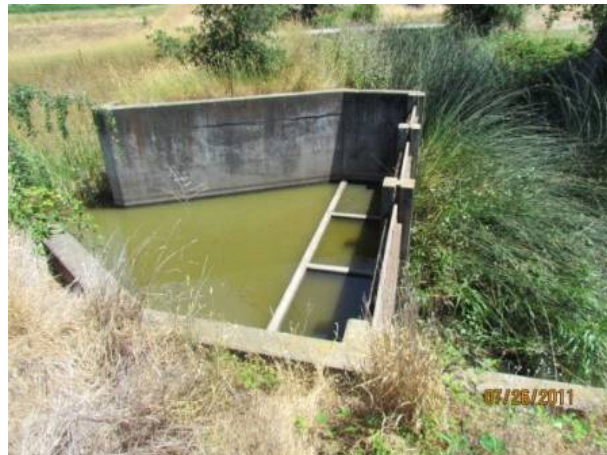
Levee Mile Report Line	15
Start Levee Mile	0.00
End Levee Mile	0.00
Location	
Category	Structures
Item	Concrete Surfaces

LMR No.	Levee Mile		Category	Item	Location *	Rating **	Action/Comment	GPS Latitude/Longitude		Issue No.
	Start	End						Start	End	Photo
15	0.00	0.00	Structures	Concrete Surfaces		A	Inspector Comments: There were minimal cracking and scaling on the concrete structure but it didn't threaten the structural integrity.	39.126317 ° -122.882733 °	39.126317 ° -122.882733 °	15 Y
16	0.00	0.00	Structures	Concrete Tilting / Settlement		A	Inspector Comments: There was no settlement or tilting observed that threaten the structure.	39.126317 ° -122.882733 °	39.126317 ° -122.882733 °	16
17	0.00	0.00	Structures	Concrete Foundations		A	Inspector Comments: No scouring or erosion was found near the structure.	39.126317 ° -122.882733 °	39.126317 ° -122.882733 °	17
18	0.00	0.00	Structures	Security Fencing		N	Inspector Comments: This item does not apply to this inspection.	39.126317 ° -122.882733 °	39.126317 ° -122.882733 °	18

View of the weir.
